**IEPA – DIVISION OF WATER POLLUTION CONTROL
DIGITAL PHOTO REPORT**

Date: 5-24-11	Site Name: Scheidairy Farms
Photo By: Kirk W. Bergstrom

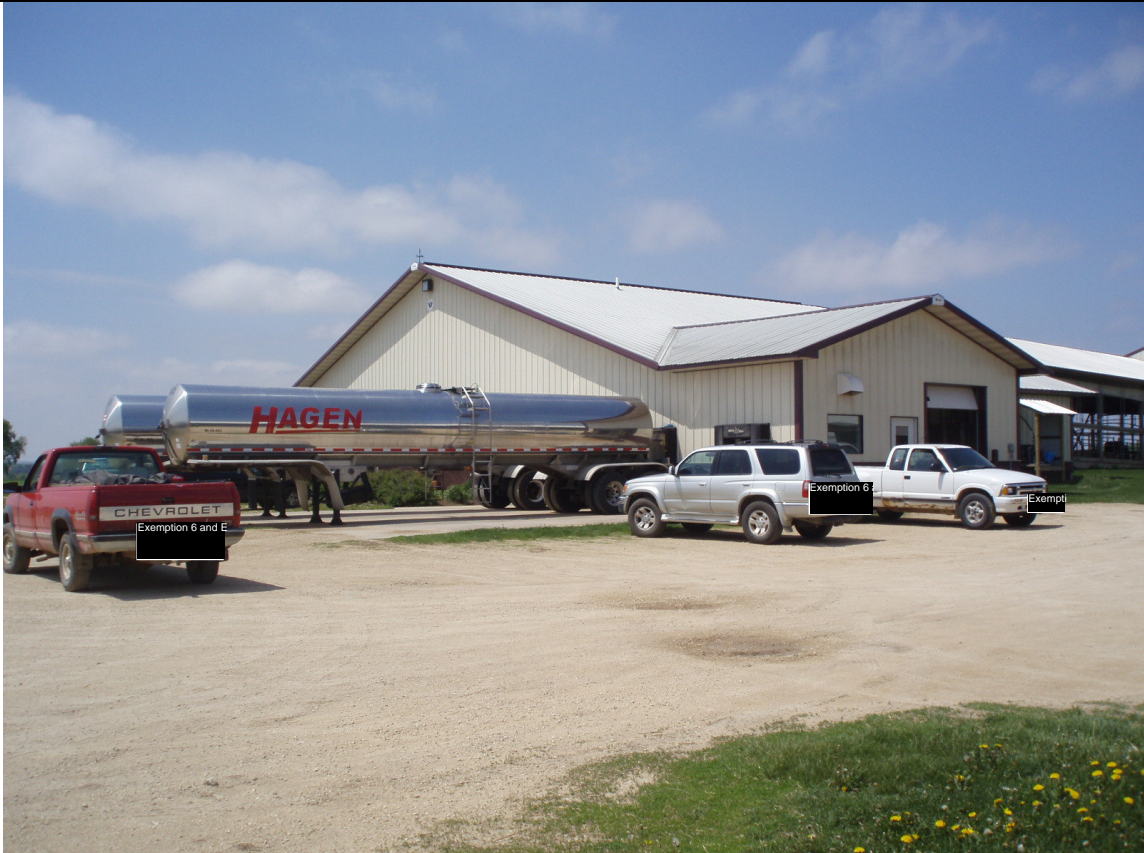
County: Stephenson	
Comments: View of office, milk parlor, and bulk tankers. View is west.	
Photo #: 1	
Photo Title: 052411_ ScheidairyFarms_KWB(4)

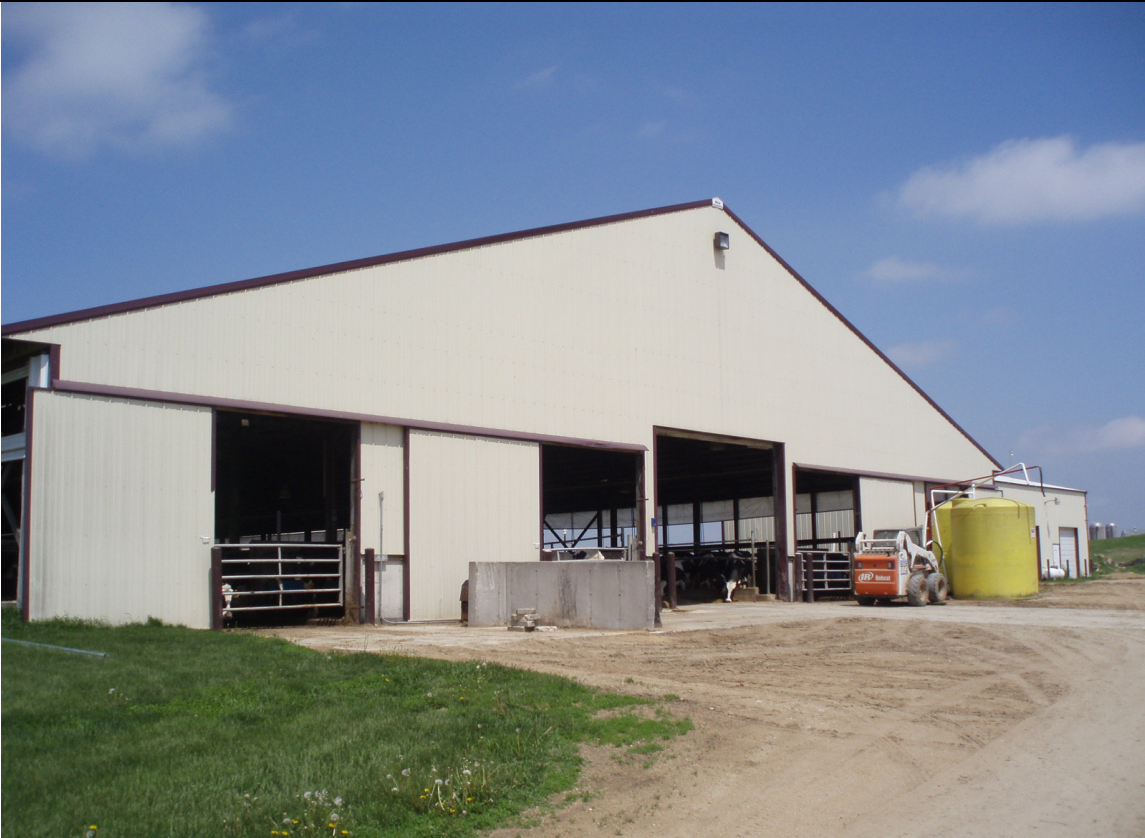
County: Stephenson	
Comments: View of freestall barn. View is northwest.	
Photo #: 4	
Photo Title: 052411_ ScheidairyFarms_KWB(5)

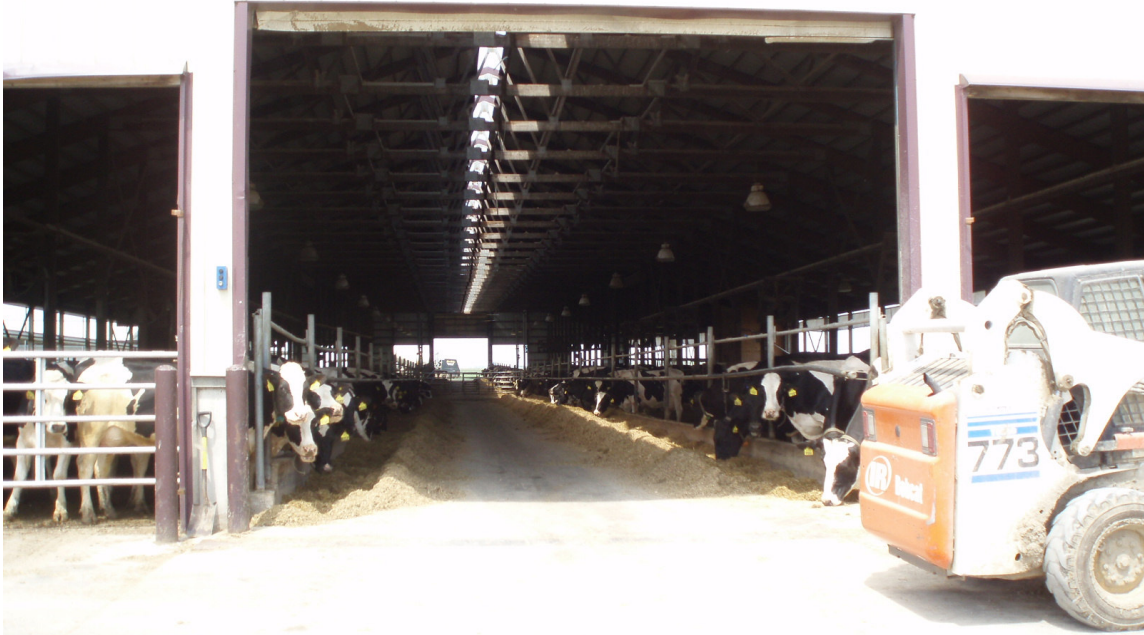
County: Stephenson	
Comments: View of freestall barn showing interior. View is northwest.	
Photo #: 5	
Photo Title: 052411_ ScheidairyFarms_KWB(8)

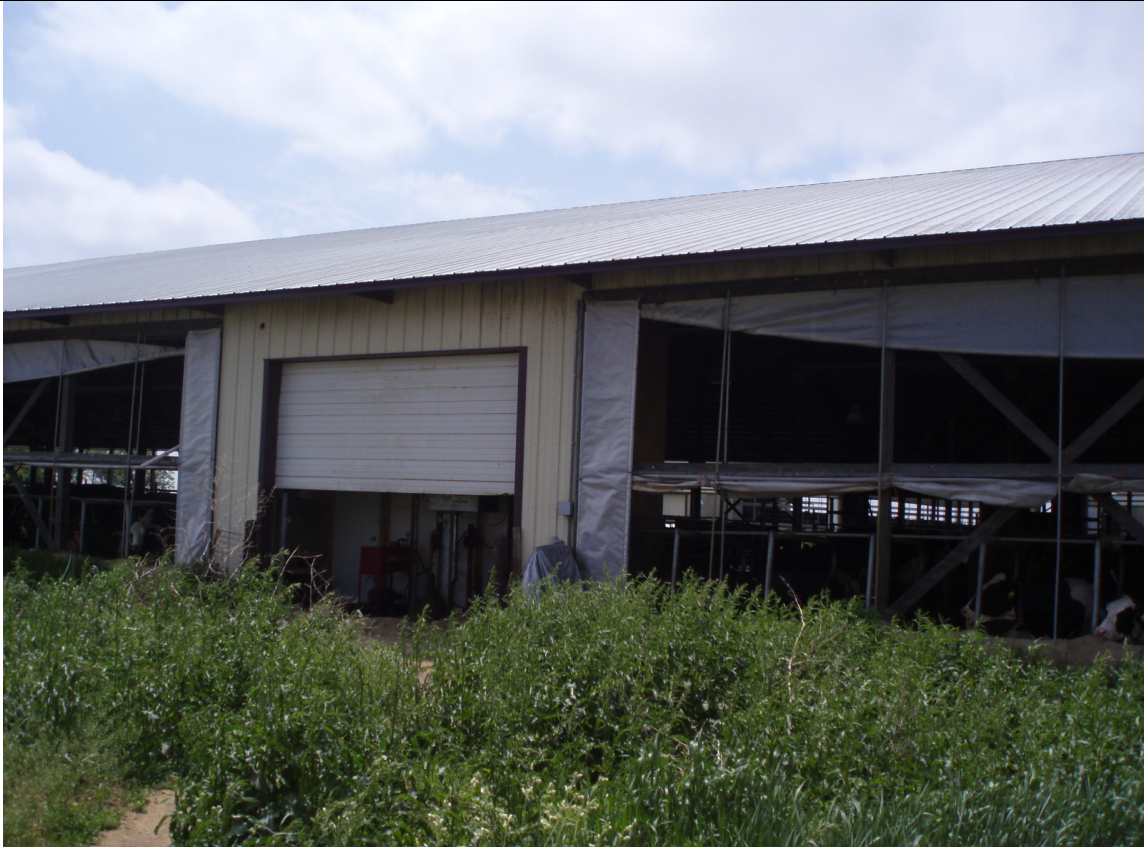
County: Stephenson	
Comments: View of freestall barn showing piston pump in garage that transfers manure to waste handling facilities.	
Photo#: 6	
Photo Title: 052411_ ScheidairyFarms_KWB(18)

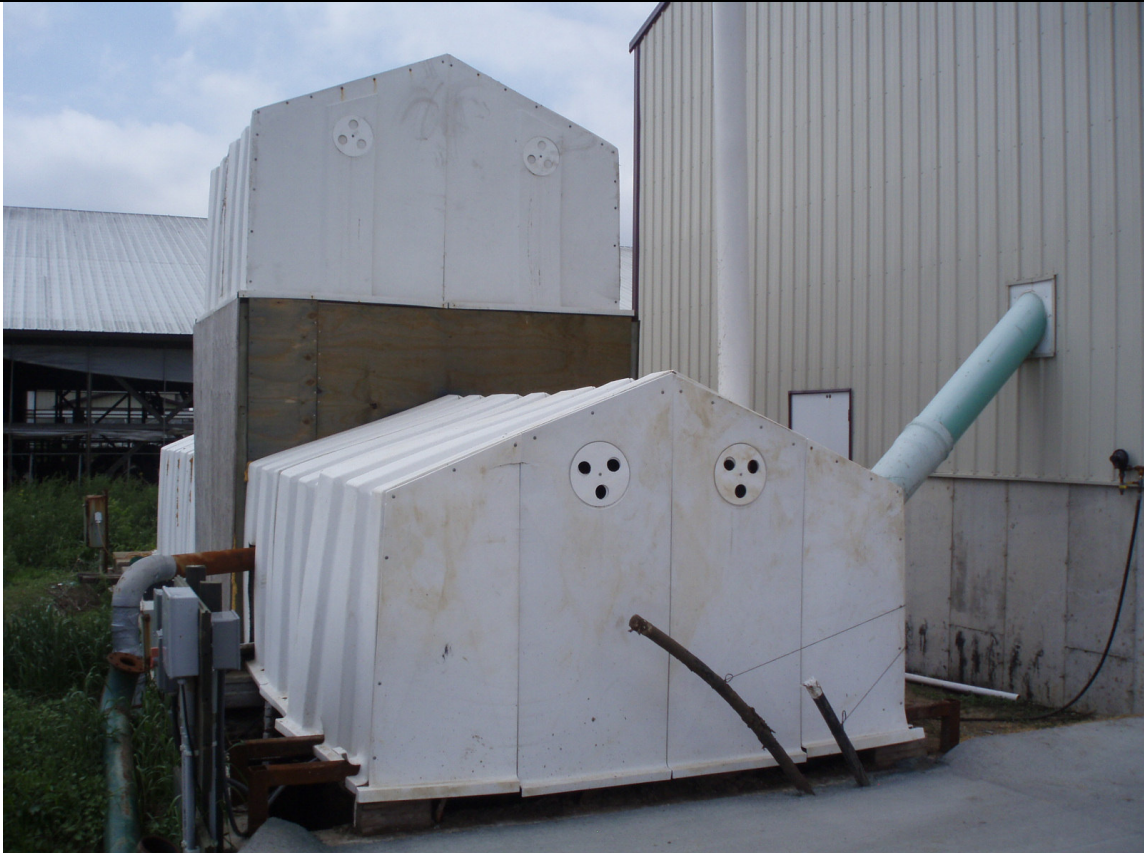
County: Stephenson	
Comments: View of covered pit housing pumps adjacent to sand separator building. Freestall barn is in background. Runoff from recycled sand storage will flow to pit via opening under the front shed. View is southwest.	
Photo #: 9	
Photo Title: 052411_ ScheidairyFarms_KWB(23)

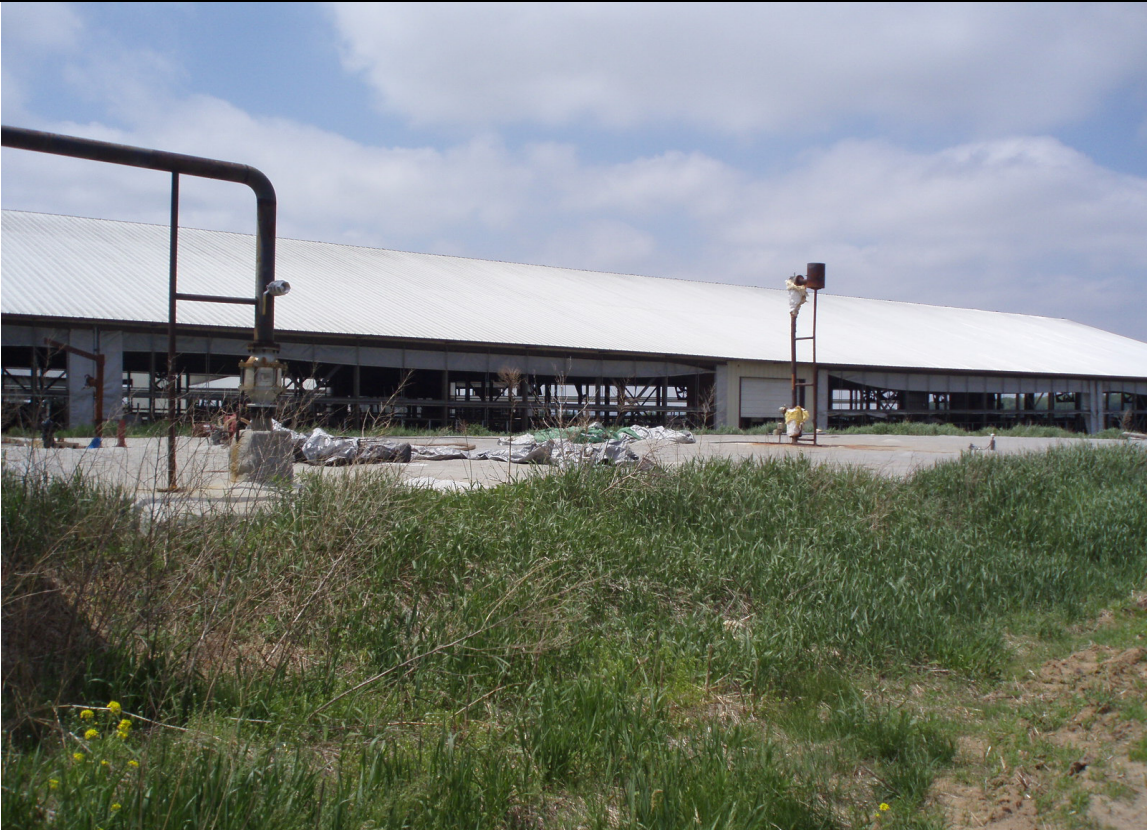
County: Stephenson	
Comments: View of anaerobic digester (700,000 gallons) with freestall barn in background. View is southwest.	
Photo #: 12	
Photo Title: 052411_ ScheidairyFarms_KWB(17)

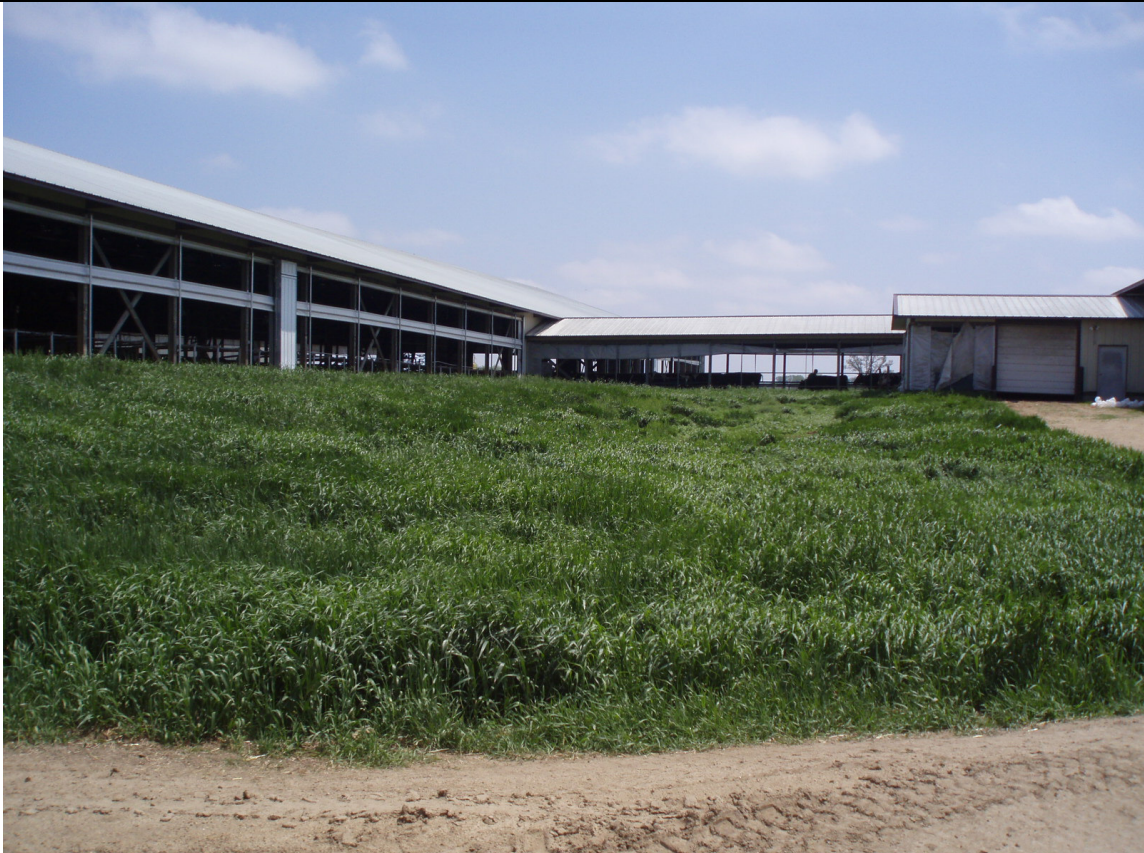
County: Stephenson	
Comments: View of freestall barn and grass swale for storm water runoff. View is southeast.	
Photo #: 13	
Photo Title: 052411_ ScheidairyFarms_KWB(33)

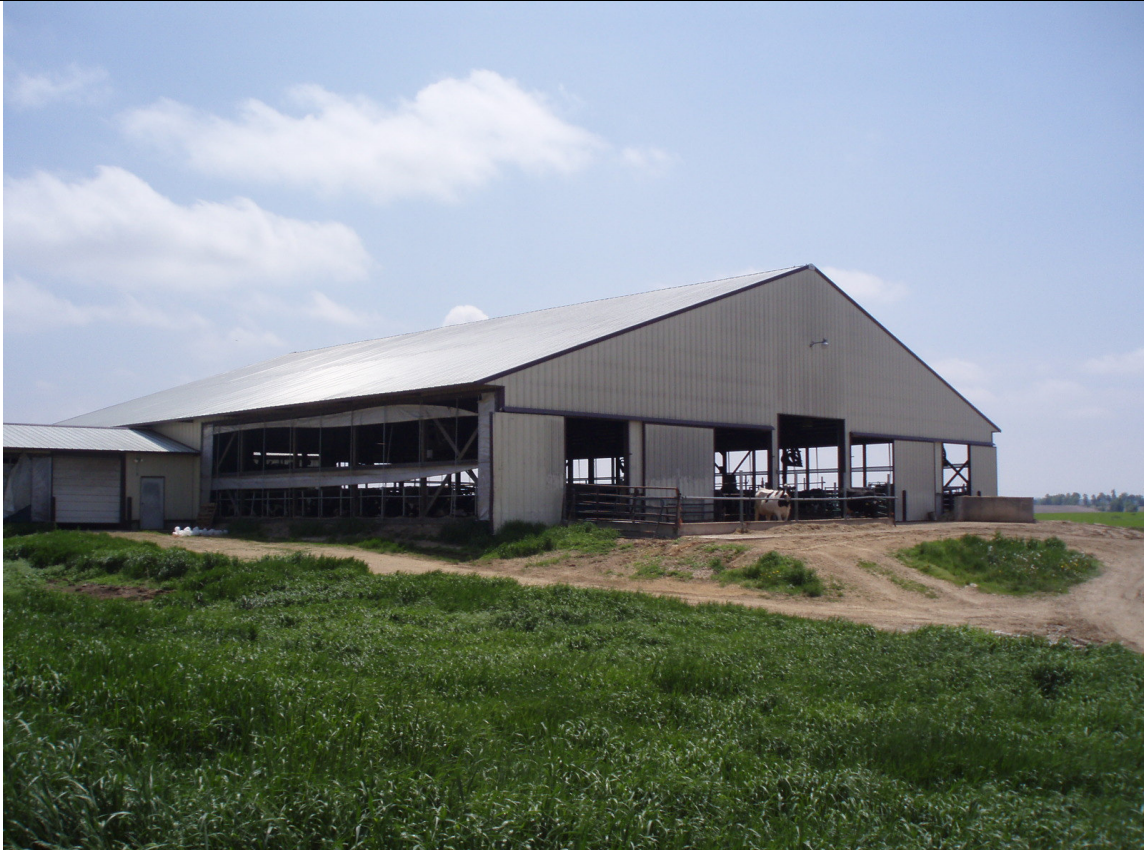
County: Stephenson	
Comments: View of special needs barn. View is southwest.	
Photo#: 14	
Photo Title: 052411_ ScheidairyFarms_KWB(32)

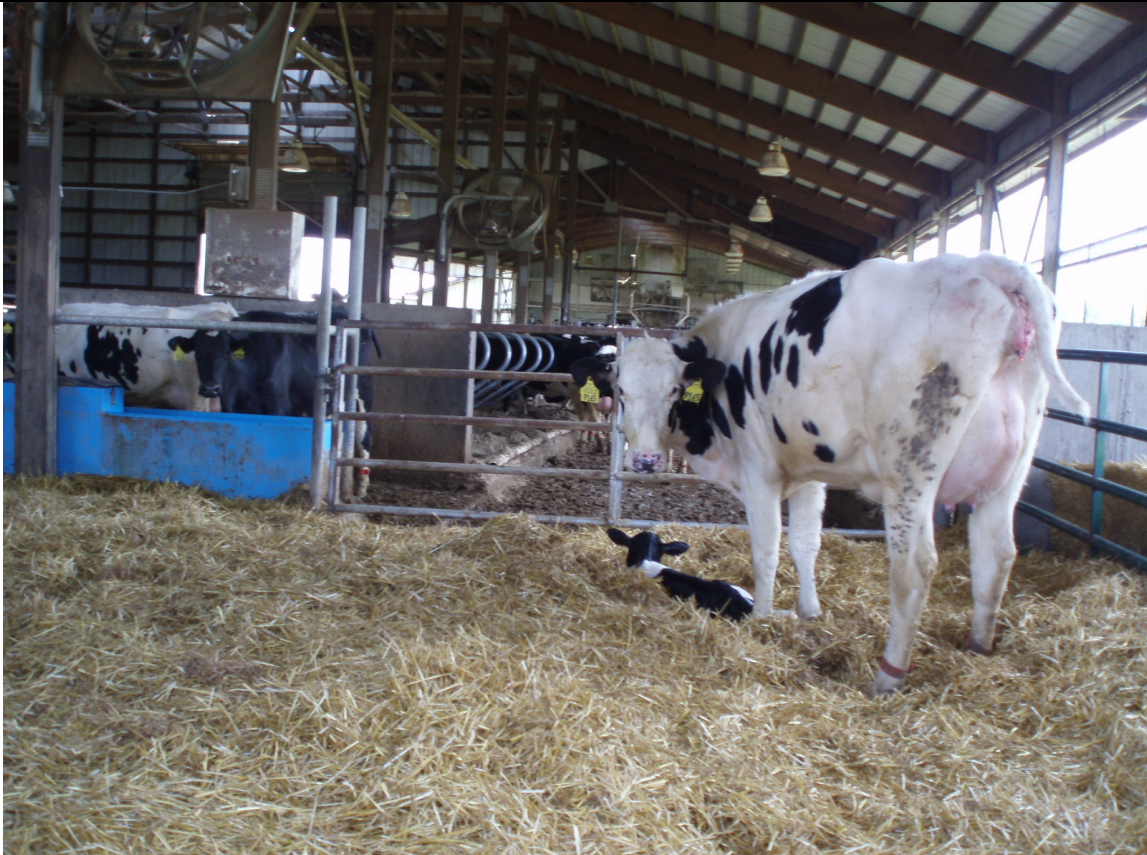
County: Stephenson	
Comments: View of interior of calving area within special needs barn.	
Photo #: 15	
Photo Title: 052411_ ScheidairyFarms_KWB(35)

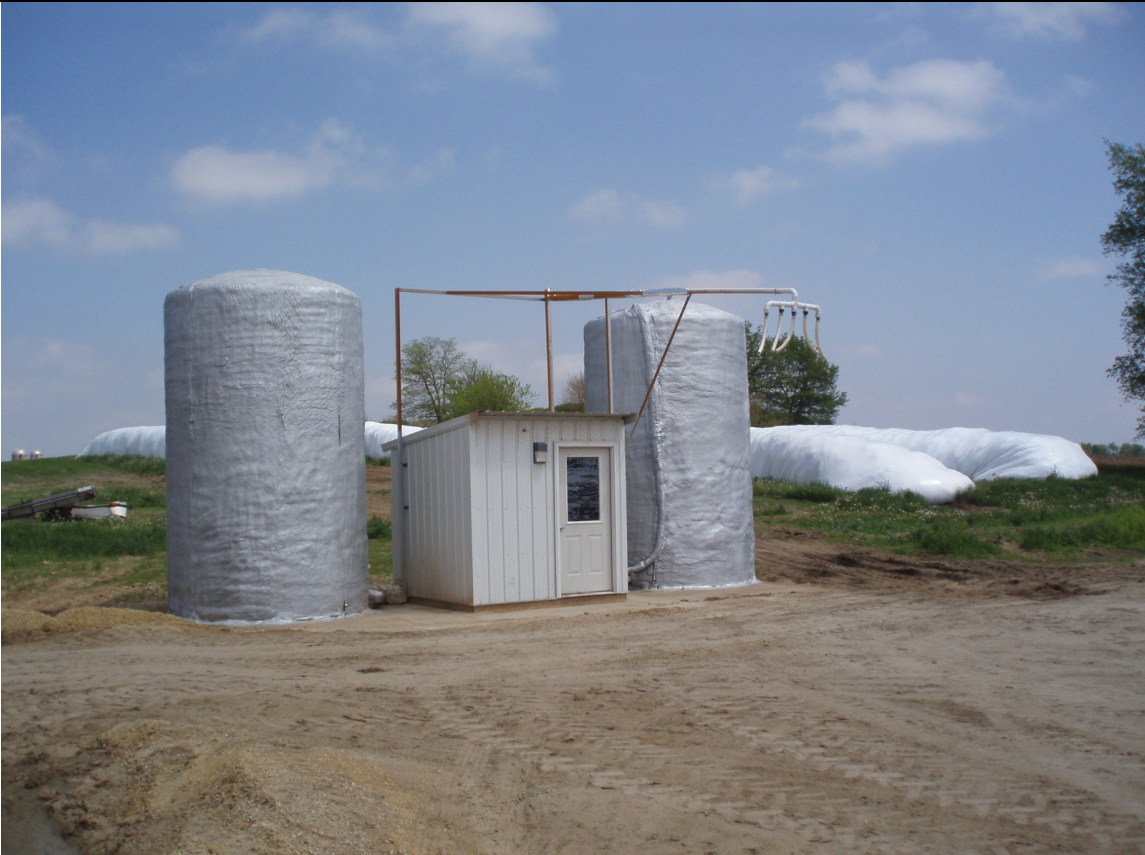
County: Stephenson	
Comments: View of the Scotta (cheese whey) holding tanks and small containment berm. Silage bags are visible in background. Runoff will flow toward point of view and then to grass swale and finally to holding pond. View is northeast.	
Photo #: 19	
Photo Title: 052411_ ScheidairyFarms_KWB(11)

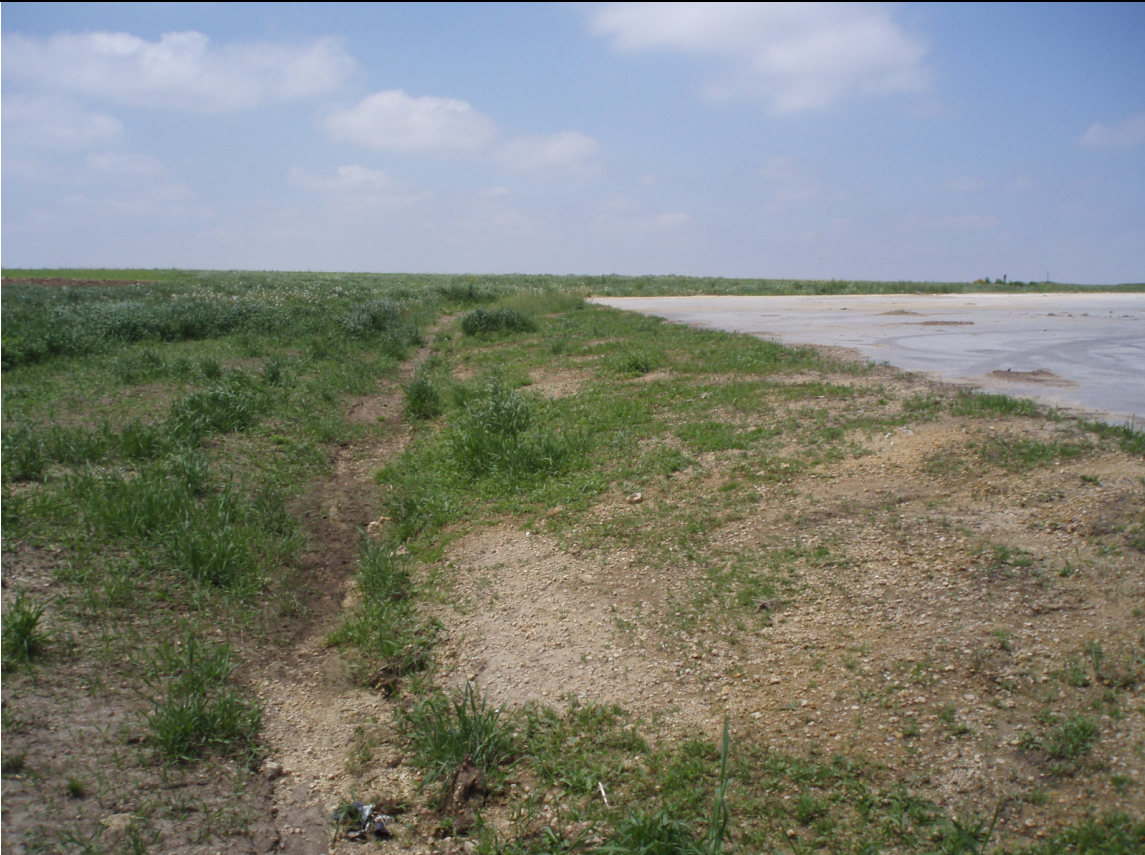
County: Stephenson	
Comments: View of swale downhill from haylage pad that will direct runoff and leachate to the holding pond.	
Photo #: 23	
Photo Title: 052411_ ScheidairyFarms_KWB(36)

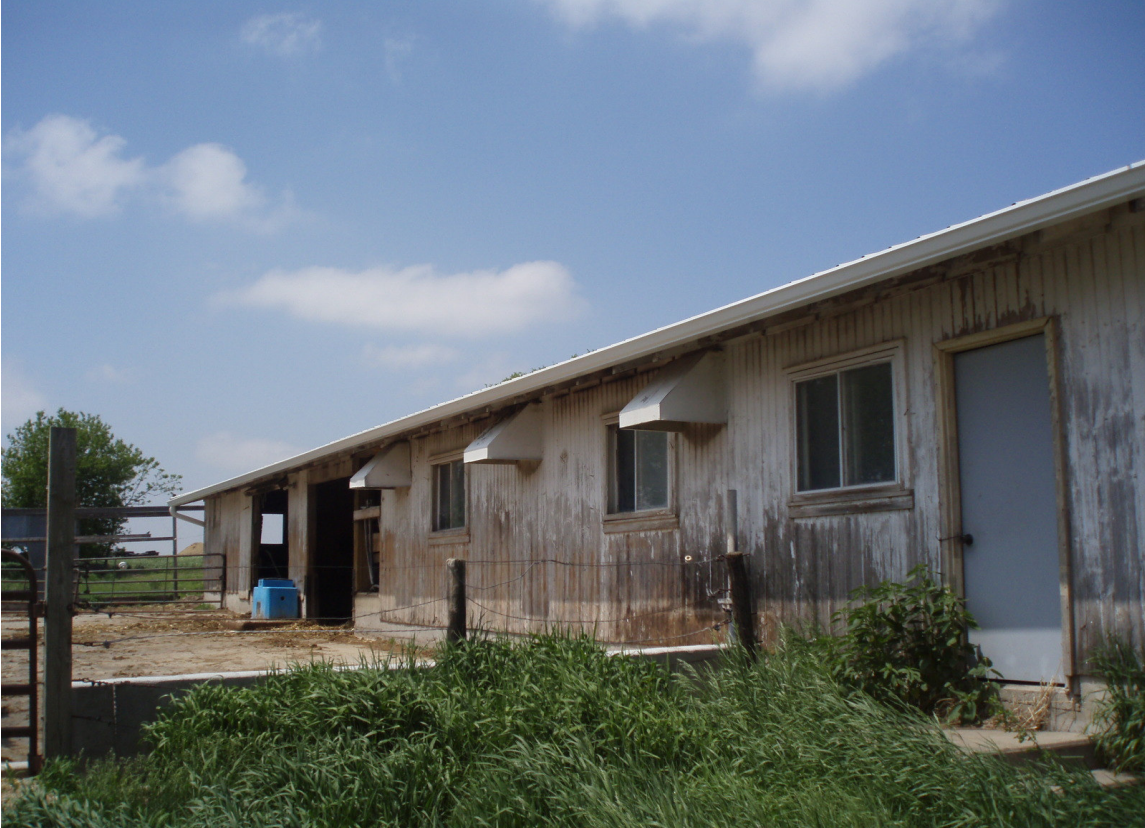
County: Stephenson	
Comments: Another view of the receiving barn. Eave gutters and feedlot containment are visible.	
Photo #: 28	
Photo Title: 052411_ ScheidairyFarms_KWB(48)

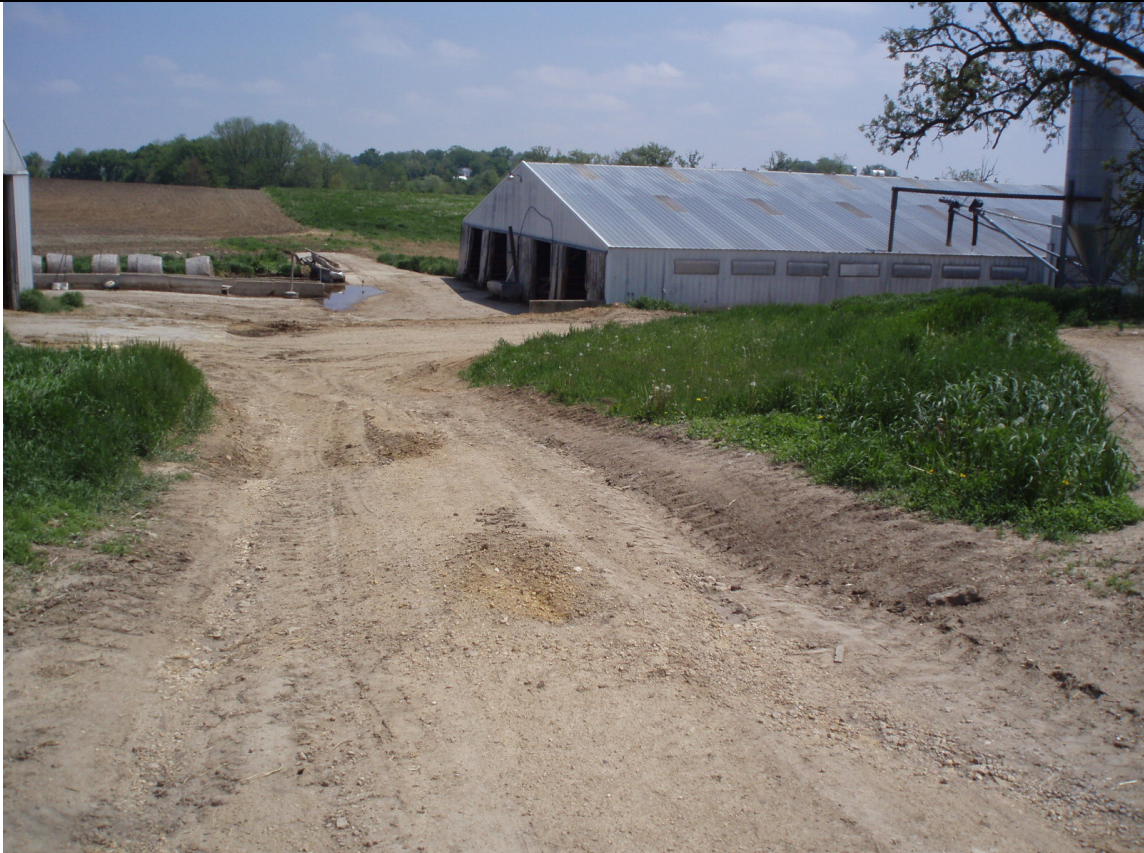
County: Stephenson	
Comments: View of the inactive freestall barn at right. Runoff from silage pads will flow to the holding pond behind the barn. View is east.	
Photo #: 29	
Photo Title: 052411_ ScheidairyFarms_KWB(40)

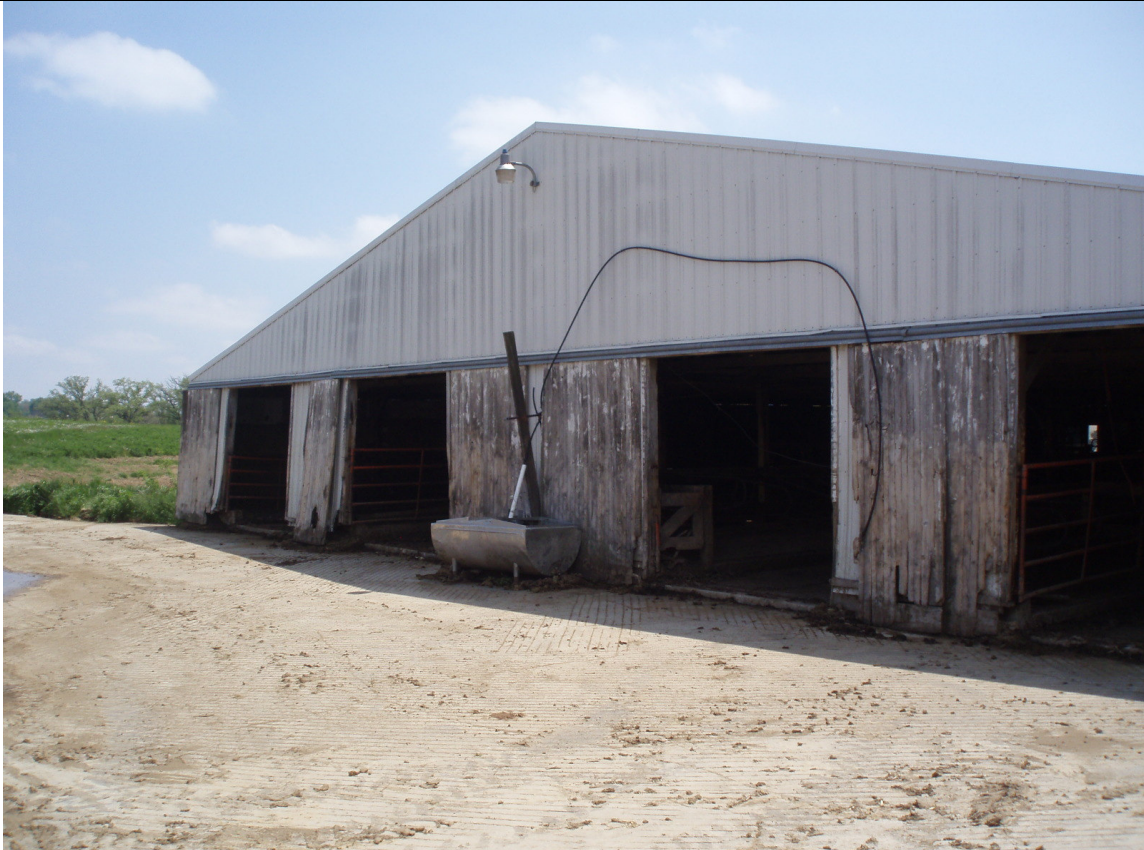
County: Stephenson	
Comments: Another view of the inactive freestall barn. View is southeast.	
Photo#: 30	
Photo Title: 052411_ ScheidairyFarms_KWB(44)

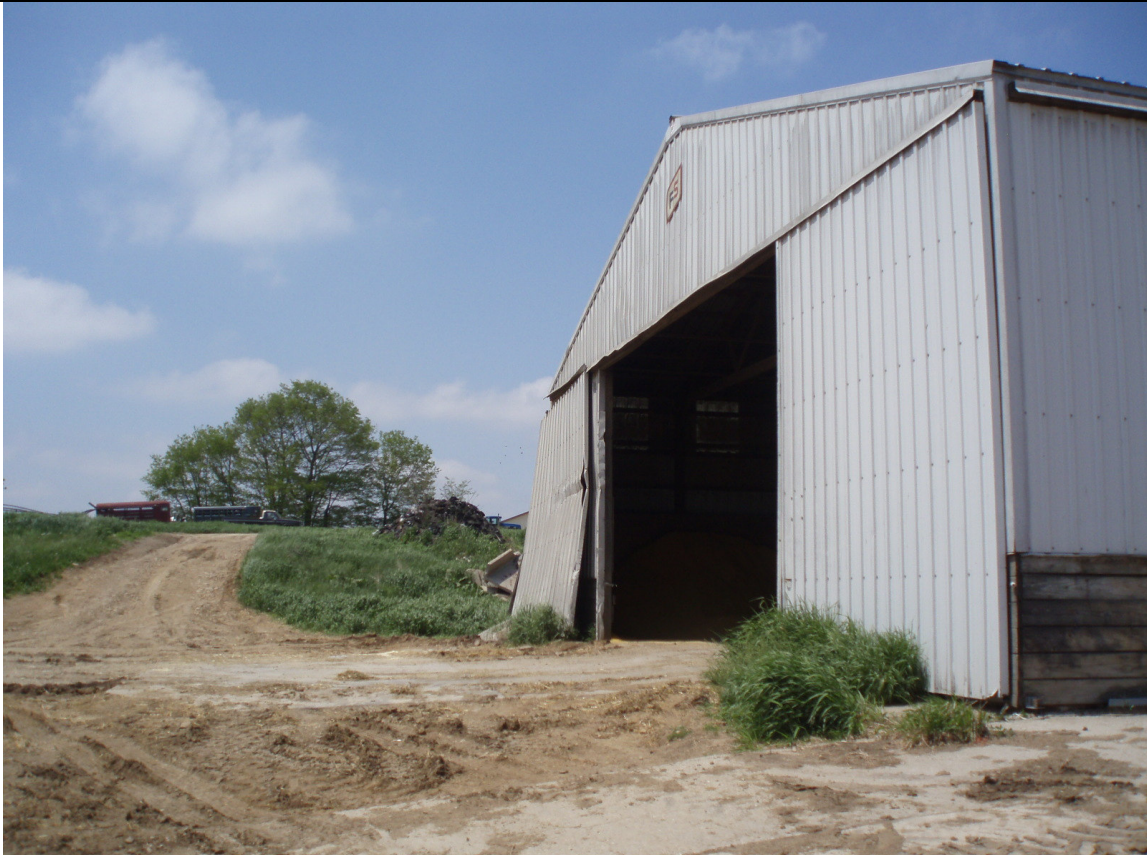
County: Stephenson	
Comments: View of the commodity storage shed. Runoff from silage pads will flow via gravel drive toward view point and then to the holding pond. View is northwest.	
Photo #: 31	
Photo Title: 052411_ ScheidairyFarms_KWB(43)
